Nexus Market Research, Inc.

**Vermont
Multi-family New Construction
Analysis of On-site Audits**

Final Report

July 13, 2009

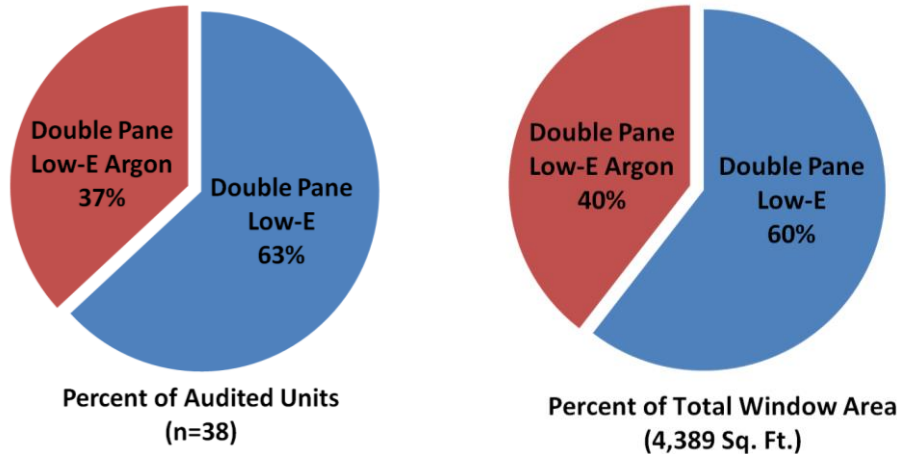
Figure 4-1: Glazing Type Percentage by Units and Total Window Area

Figure 4-1 through Figure 4-4 show the percentage of audited units and the percentage of total window area by type of glazing, by U-value, by frame type, and by thermal break. As shown, the percentages by audited units and total window area are similar.

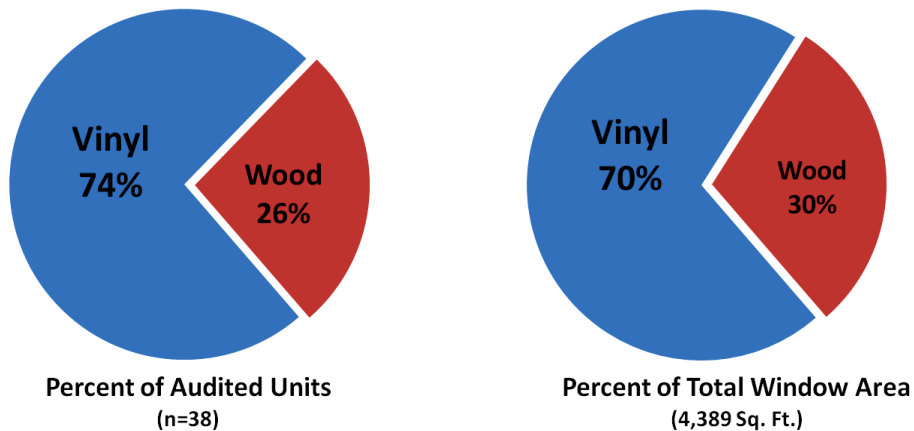
Figure 4-3: Frame Type Percentage by Units and Total Window Area

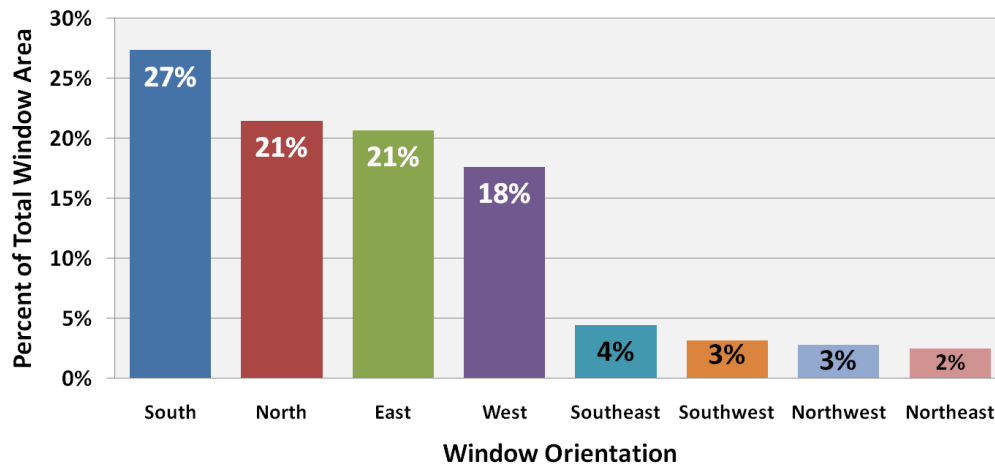
Orientation: Figure 4–5 shows the percentage of total window area by orientation; over one-fourth (27%) of window area is oriented to the south.

Figure 4–5: Window Orientation—Percent of Total Window Area

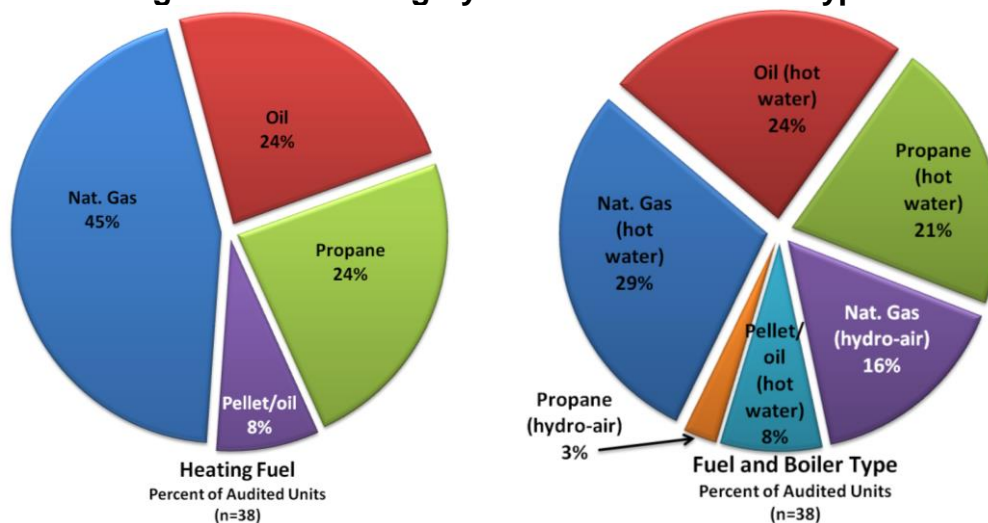
All of the inspected units have boiler heating systems; five units in three projects have hydro-air boiler systems, the rest are hot water boilers. Some units have individual heating systems and in other cases one system serves multiple units. The first pie chart in Figure 4–6 shows that 45% of the inspected units are heated by natural gas, 24% by oil, 24% by propane, and 8% by a pellet boiler with oil boiler backup.⁹ The second pie chart in Figure 4–6 shows the percentage of units heated by various fuel/boiler type combinations. As shown, the most frequently observed combination is natural gas hot water boilers (29%), followed closely by oil (24%) and propane (21%) hot water boilers.

Figure 4–6: Heating System Fuel and Boiler Type

⁹ The units heated by a pellet hot water boiler are in a 52-unit senior housing project that has a backup oil-fired hot water boiler heating system.
